## Hurricane Matthew Power System Challenges and Lessons Learned at Southeastern Regional Medical Center in Lumberton, NC

# Timeline of Events Surrounding Failure of Emergency Power System Components at Southeastern Regional Medical Center

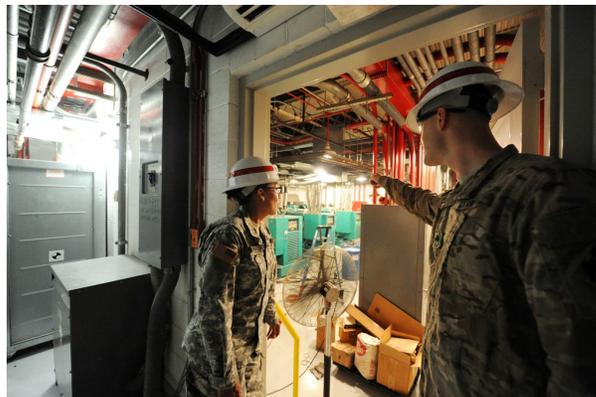
US Army Corps of Engineers personnel shown during the operation to augment emergency power at Southeastern Regional Medical Center following Hurricane Matthew.

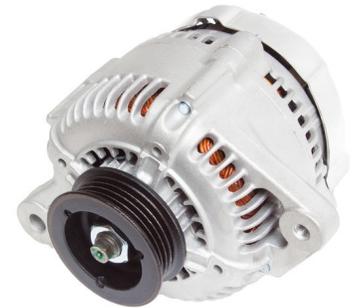
## Lesson # 2: Failure of Hard-to-Replace Spare Generator Part Crippled Generator

for Two Weeks - The turbo charge component of Generator Unit # 1 failed hours after utility power was lost on October 8, 2016, despite having been tested the previous day. This part had to be ordered from a supplier in Belgium, resulting in a two-week delay until the generator was running properly. (The remaining four gen sets provided reduced backup power for the hospital for four days until a fourth unit was disabled due to a mechanical malfunction).

**Lesson Learned:** Work with your generator service provider to identify critical spare parts for gen sets and have these parts either on site or with your generator service provider.

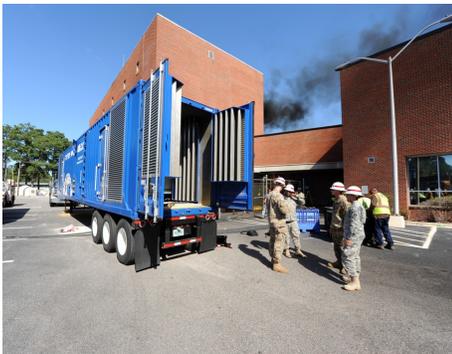
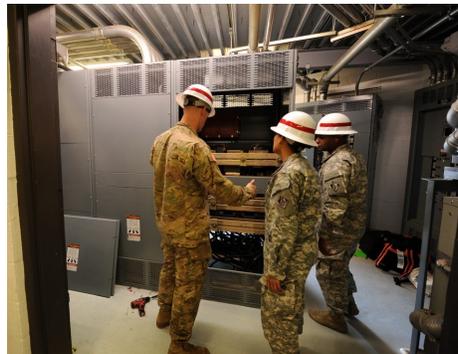
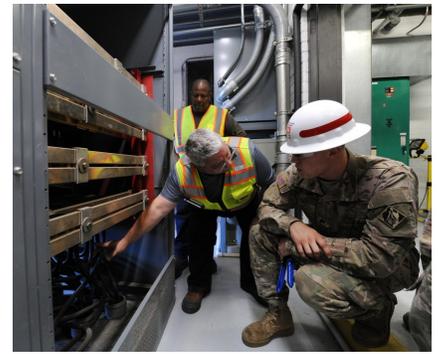
US Army Corps of Engineers personnel shown during the delivery and installation of a temporary replacement generator at Southeastern Regional Medical Center following Hurricane Matthew.
